Installation errors: misalignment of valve spring

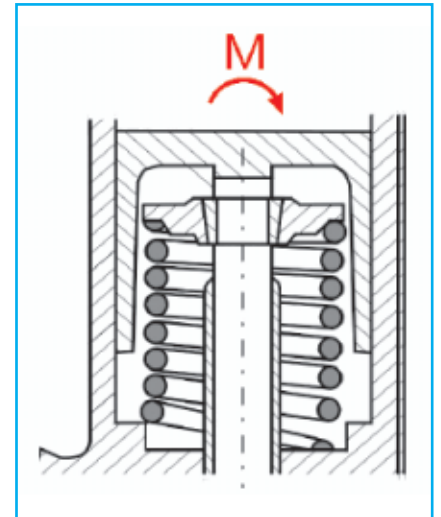
The supporting area for the valve spring at the cylinder head shows impressions of irregular depth. The valve spring is supported on one side of the higher cast edge. (See fig. 1 / spot 2 and fig. 2)

Due to the installation position (see fig. 2), the valve spring generates a torque on the valve stem via the upper spring seat. The torque exerts a lateral force onto the end of the valve stem, thus causing a bending stress which leads to a valve stem rupture in the groove area of the valve.

Fig.2: Valve spring tilted at the higher cast edge

When the valve spring is installed, it must sit flat on the bearing surface in the cylinder head. A tilted installation of the valve spring leads to a breakage at the valve stem end and strong wear on the valve guide, resulting in costly engine damage.

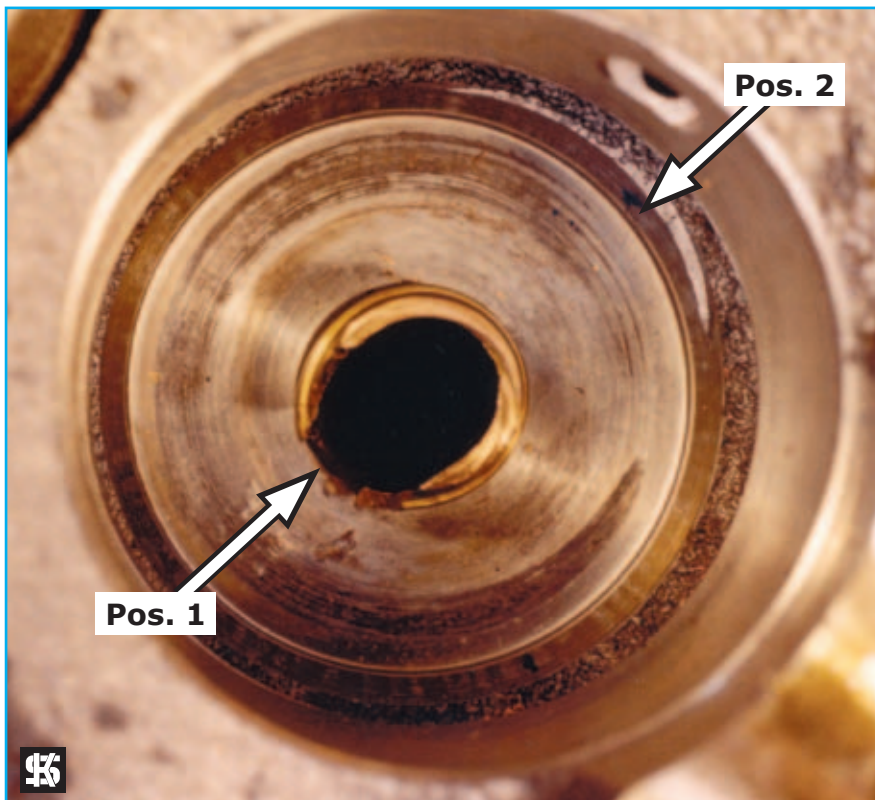
In fig.1 / spot 1, eccentric wear as well as material breakage at the valve guide end are clearly visible.

The transversal breakage of the valve in the groove area and the damage of valve guide are caused by misalignment of the valve spring.

Fig.1: Valve guide damage, Eccentric wear on the valve guide caused by bending stress of the valve stem.
