Vacuum Pump Damage

Insufficient lubrication due to incorrect assembly

Vehicle:	Engine identification:	Product:	Vacuum pump
Peugeot, Citroën with 1.8/1.9 l Diesel engine	XUD7, XUD9A, XUD9AU, XUD9TE, XUD9Y, D9B	Pierburg No.:	7.21174.90.0/94.0/95.0

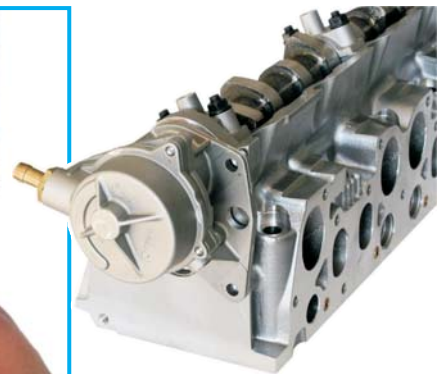
Vacuum pump fitted to the cylinder head

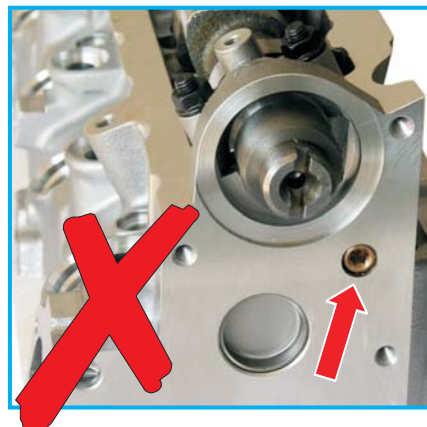
Important: Proper lubricating oil supply to the vacuum pump

In the case of vacuum pumps which are driven by the camshaft, this closure screw must be removed from the cylinder head.

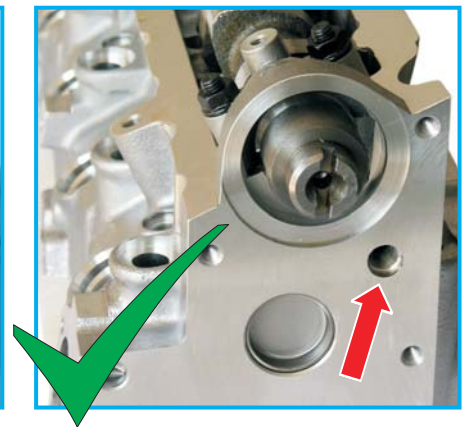
If this is not done, the vacuum pump will suffer a total failure due to insufficient lubrication already when being operated for a short period of time.
