Vacuum Pump Damage

Insufficient lubrication due to incorrect assembly

Vehicle:	Engine identification:	Product:	Vacuum pump
Peugeot, Citroën with 1.8/1.9 l Diesel engine	XUD7, XUD9A, XUD9AU, XUD9TE, XUD9Y, D9B	Pierburg No.:	7.21174.90.0/94.0/95.0

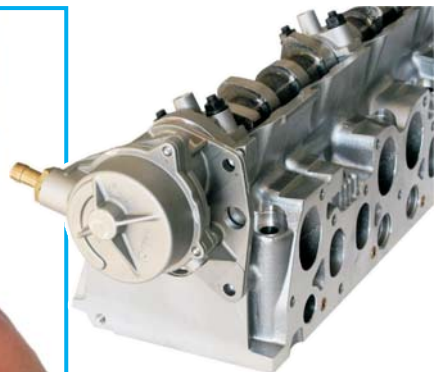
Vacuum pump fitted to the cylinder head

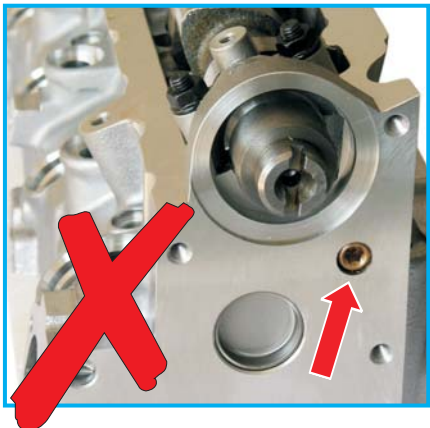
Important: Proper lubricating oil supply to the vacuum pump

In the case of vacuum pumps which are driven by the camshaft, this closure screw must be removed from the cylinder head.

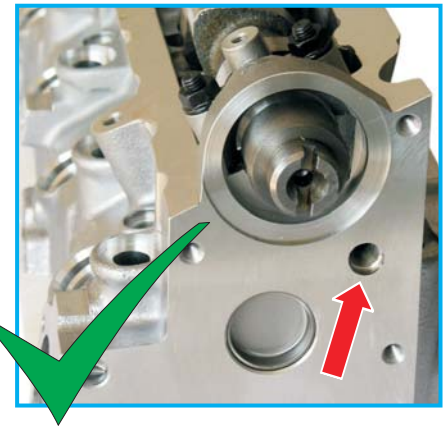
When replacing the cylinder head within the scope of an engine repair, the closure screw was not removed which seals off the opening of the lubricating oil supply to the vacuum pump.

If this is not done, the vacuum pump will suffer a total failure due to insufficient lubrication already when being operated for a short period of time.

! Before installing a new vacuum pump the lubricating oil supply system must be checked under all circumstances!
