Stem Fractures on Intake and Exhaust Valves

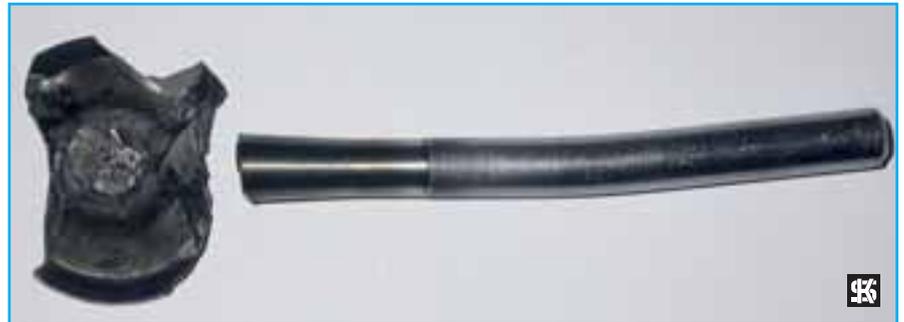
Fig. 1

In the case in question, only the deformed valves were replaced in the course of a cylinder head repair (the toothed belt had broken). A short time after the vehicle was on the road again, there was another damage of the valve train. On dismantling the engine, a valve was discovered that was broken on its valve stem end and valve head. An examination of the parts showed that the valve stem end has been broken first, namely in the area of the lower recess for the valve cotters.

During further course of the damage, the valve fell into the combustion chamber where it collided with the piston and has been destroyed.

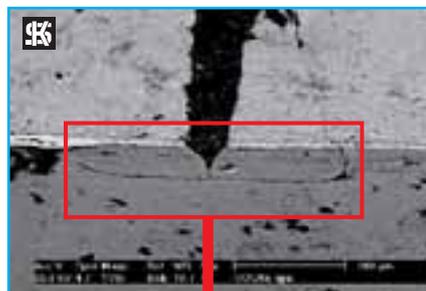
Fig. 2

After cutting through the point of fracture at the lower recess for the valve cotters (Fig. 2 to 4), another crack parallel to the main point of fracture is perceptible. Such parallel cracks are a clear indication of overload fractures. Due to the high transversal load on the valve stem end, several incipient cracks formed which, in the course of the further spreading of damage, resulted in the development of one the main cracks and consequently in the main point of fracture. A particularity of this damage is the fact that there was an impurity inside the incipient crack by a foreign metal (Fig. 4). The material analysis showed that this was a copper-zinc alloy, definitely a valve guide material.

On inserting the valve, material from the valve guide settled in the lowest of the three cotter fastening grooves. Presumably the guide was not completely cleaned subsequent to machining or the material was scraped off by the valve during insertion. The foreign material became jammed in the recess while assembling the valve-spring resulting in a slant fit of the valve-spring retainer. In addition, the valve was hindered in its natural rotation.

In order to avoid valve fractures, it is urgently recommended to pay attention to cleanliness and to also consistently replace the interacting sliding parts of the valves. In particular newer valves with valve stem diameters of 7 mm or less react sensitively to alignment errors and inaccuracies of shape. It is therefore also recommended always replacing valve cotters as well, any time the valves are changed.

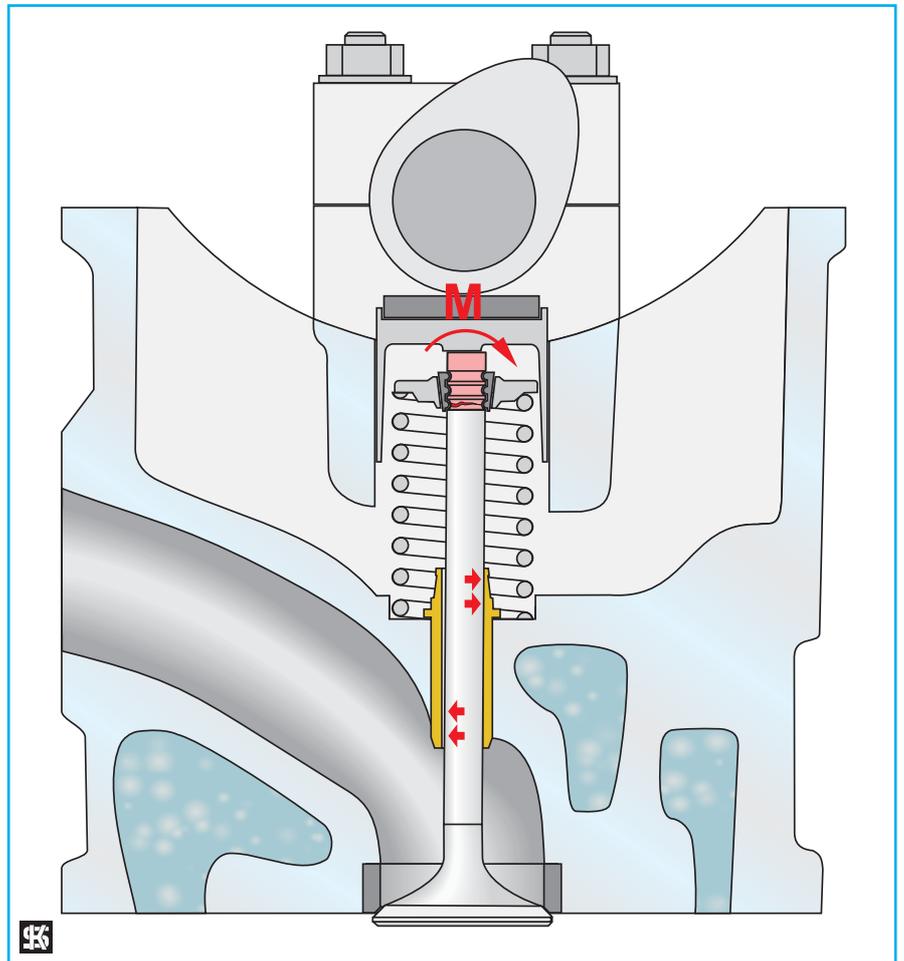
Fig. 5

As a result of the slant position of the valve-spring retainer, a bending moment occurred on the valve stem end (Fig. 5) and result in the fracture of the valve in the lower fastening groove.

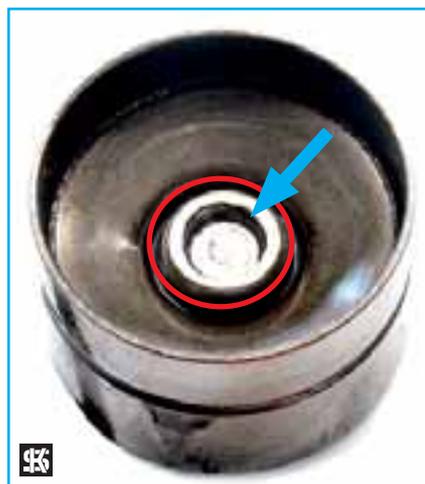
Fig. 6

material thickness. Figure 6 shows a hydraulic valve tappet which has been severely dented by the valve stem as a result of a toothed belt fracture on the working surface of the valve. Unfortunately, damage of this kind is often overlooked, especially if they are not very distinctive, and the tappets are reinstalled. It is then only a matter of minutes until the engine fails again after repair.

To avoid costly follow-up repairs, hydraulic valve tappets should be always replaced when repairing cylinder heads with a mileage of 120,000 or more.
