Bearings without locating lugs

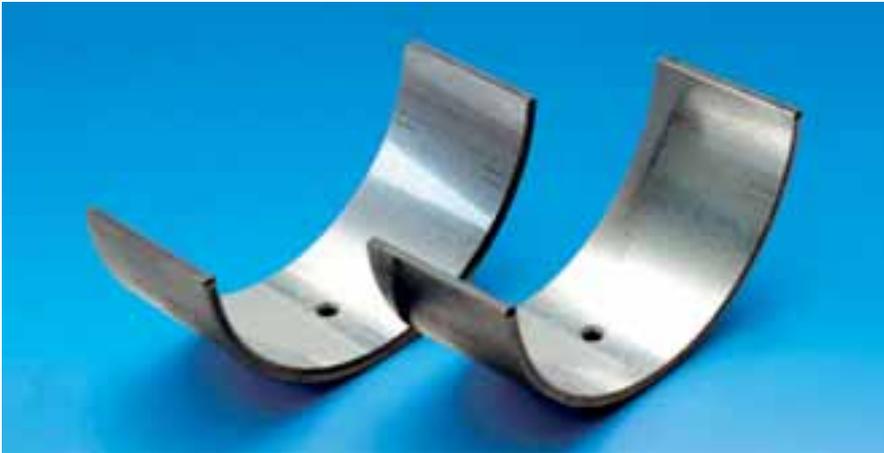
Fig. 1

Various manufacturers have switched over from manual engine assembly to semi or completely automated production lines. This has produced changes in the design of the main and connecting rod bearings. For some types of bearings the locating lugs of the bearing shells have been eliminated (Fig. 1).

Locating lugs are irrelevant to the safe functioning of bearing shells. If bearing shells are supplied without lugs in the future for certain engines, they can also be used. The assembly will be carried out the same way. In this case the notches left in the housing bores for the lugs will remain unused. One must just be careful to ensure that the bearing shells are centred in the housing bore (axial alignment). Any mechanic will doubtlessly be able to do this manually just as well as a robot.

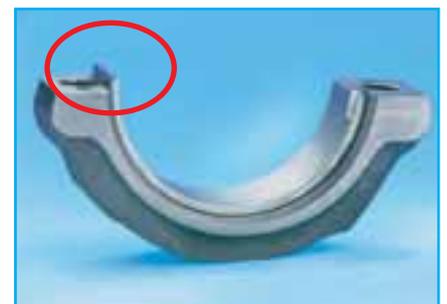
Fig. 2

true that the bearing shells are held in place by the surface pressure in the housing bores when the bearing caps are being tightened. The surface pressure is achieved by the bearing crush height which is shown in Figure 2 in an extremely exaggerated form. In reality the crush height is only a few hundredths of a millimetre. The crush height produces surface pressure on the entire back of the shells, which holds the bearing shells securely in place after tightening. Therefore, when engine blocks or connecting rods are being overhauled, close attention must be given to ensure that the housing bores are within the dimensions specified by the manufacturer. If the housing bores are too large (as is the case after a seizure), the locating lugs are by no means able to hold the bearing shells in place or to prevent bearing spinning.
