Electric EGR Valves

Matching to the engine controller is required

Vehicle:	Product:	Electric EGR valve
various VW, Seat, Skoda, Audi	Pierburg No.: 7.22574.11.0; 7.28070.02.0; 7.28248.16.0 7.22785.11.0/12.0/13.0/14.0	O.E. No.: various

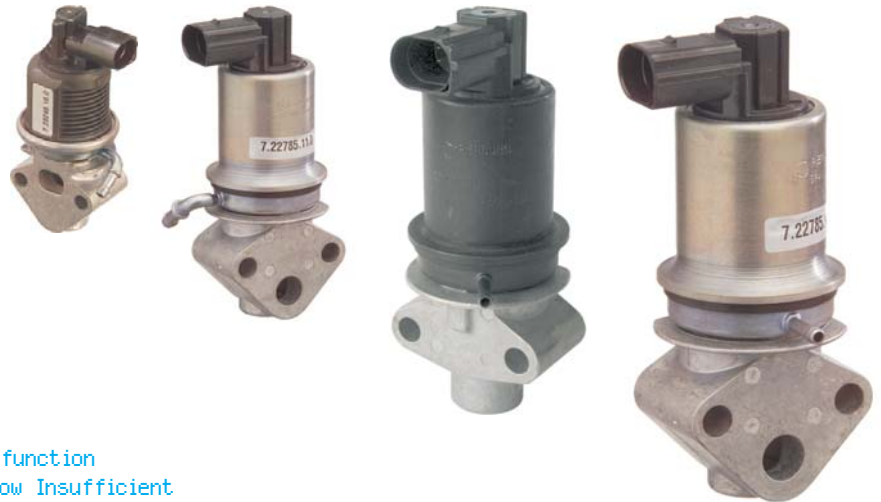
Different electric EGR valves

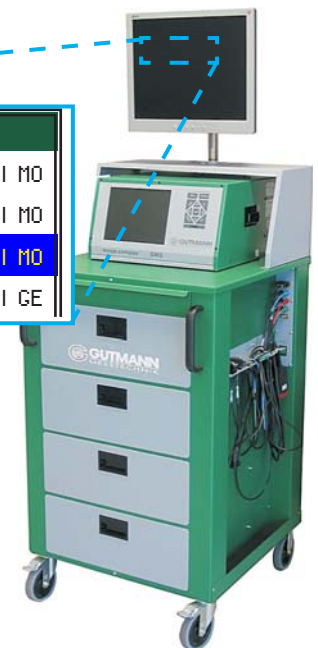
Basic adjustment	
Adaption throttle body control unit	I MO
Check Lambda Converting Bank 1	I MO
Adaption EGR valve	I MO
Reset gear data	I GE

Output for EGR valve matching
(Gutmann engine tester, for example)

The electric EGR valve must be adapted to the engine controller!

This is done by selecting a special programme of the engine tester ("default setting", for example).
